The Consultant

An Engineering and Investigations Newsletter

November 2002

Could Excess Moisture Be Ruining Your Flooring?

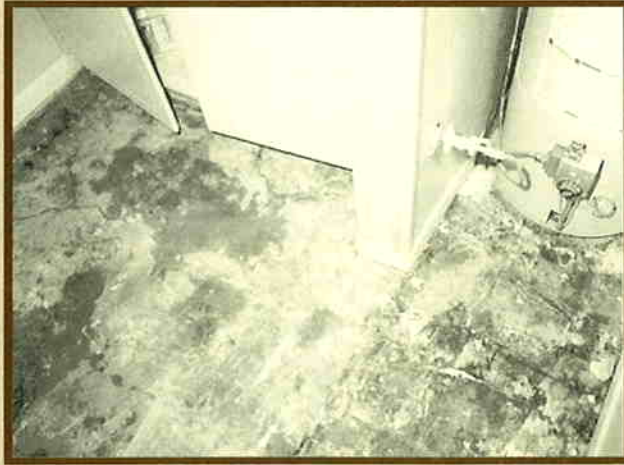
Excess moisture damage to concrete sub flooring.

Floor manufacturers recognize that excess sub floor moisture can effect flooring and adhesive performance to concrete or wood sub flooring. However, not all floor suppliers or installers know of or pay attention to this potential problem. Moisture problems can effect carpet, wood, laminated synthetic wood, linoleum, vinyl, tile and most other flooring commonly used in residential or commercial construction. The excess moisture can result in warping, rot, mold, discoloration and latex adhesive bond failure, as well as causing latex adhesives to seep through the seams in flooring. The adhesive oozing through the seams dries and becomes tacky. Normal floor dirt will adhere causing dark discoloration paralleling the seams and joints of the flooring.

Excess moisture can come from sources such as new concrete, plumbing leaks, spills, poor surface drainage, surface runoff, inadequate vapor barrier, direct rainfall when a roof is compromised or from water applied during a fire. Freshly poured concrete contains water critical to the curing and hardening of concrete. Concrete continues to cure even several months after it is poured. During the ongoing curing process, moisture trapped beneath flooring laid too soon can continue to be released from the concrete. Increased amounts of water can be trapped in new concrete when it is exposed to rainfall prior to final enclosure with a roof. Plumbing leaks above a floor or

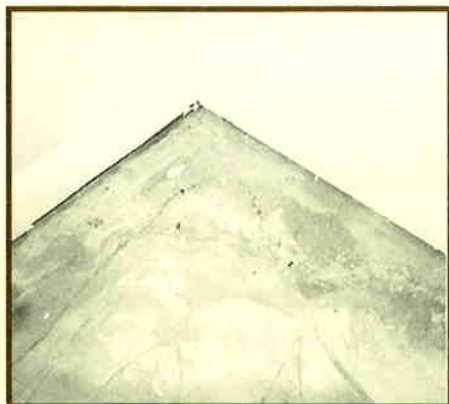
Mineral deposits from excess moisture in sub flooring.

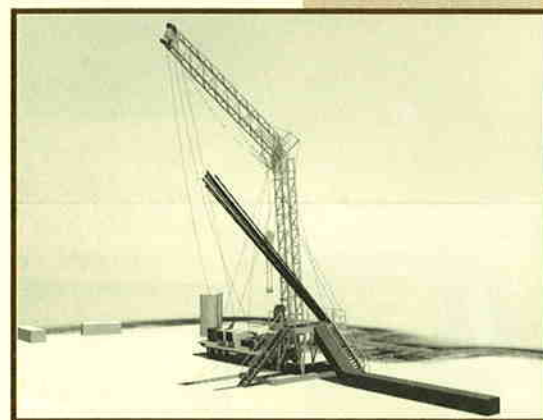
Simulation of an oilrig reconstruction.

was involved in beta testing a program called Human Vehicle Environment (HVE) by Engineering Dynamics Corporation (EDC). We became one of the first users of the PC-based version. This year we acquired a vehicle model library that includes thousands of makes and year models, so that they would be readily available for client projects. Although this library does not include every foreign and domestic vehicle, it covers many of the most common vehicles, motorcycles, semi-trucks and semi-trailers. When necessary, SEAL can create custom vehicles using our in-house graphics department. We have created dozers, concrete barriers, crash attenuators and even an oilrig, just to name a few.
